FEDERAL ENERGY REGULATORY COMMISSION
Office of Energy Projects
Division of Dam Safety and Inspections – Portland Regional Office
805 SW Broadway, Suite 550
Portland, Oregon 97205
(503) 552-2700 Office - (503) 552-2799 Facsimile

In reply refer to:
P-2496

Subject: Dam Safety Incidents near Station 120+80 and Ames, Leaburg Canal
Development, Leaburg-Waltermville Project

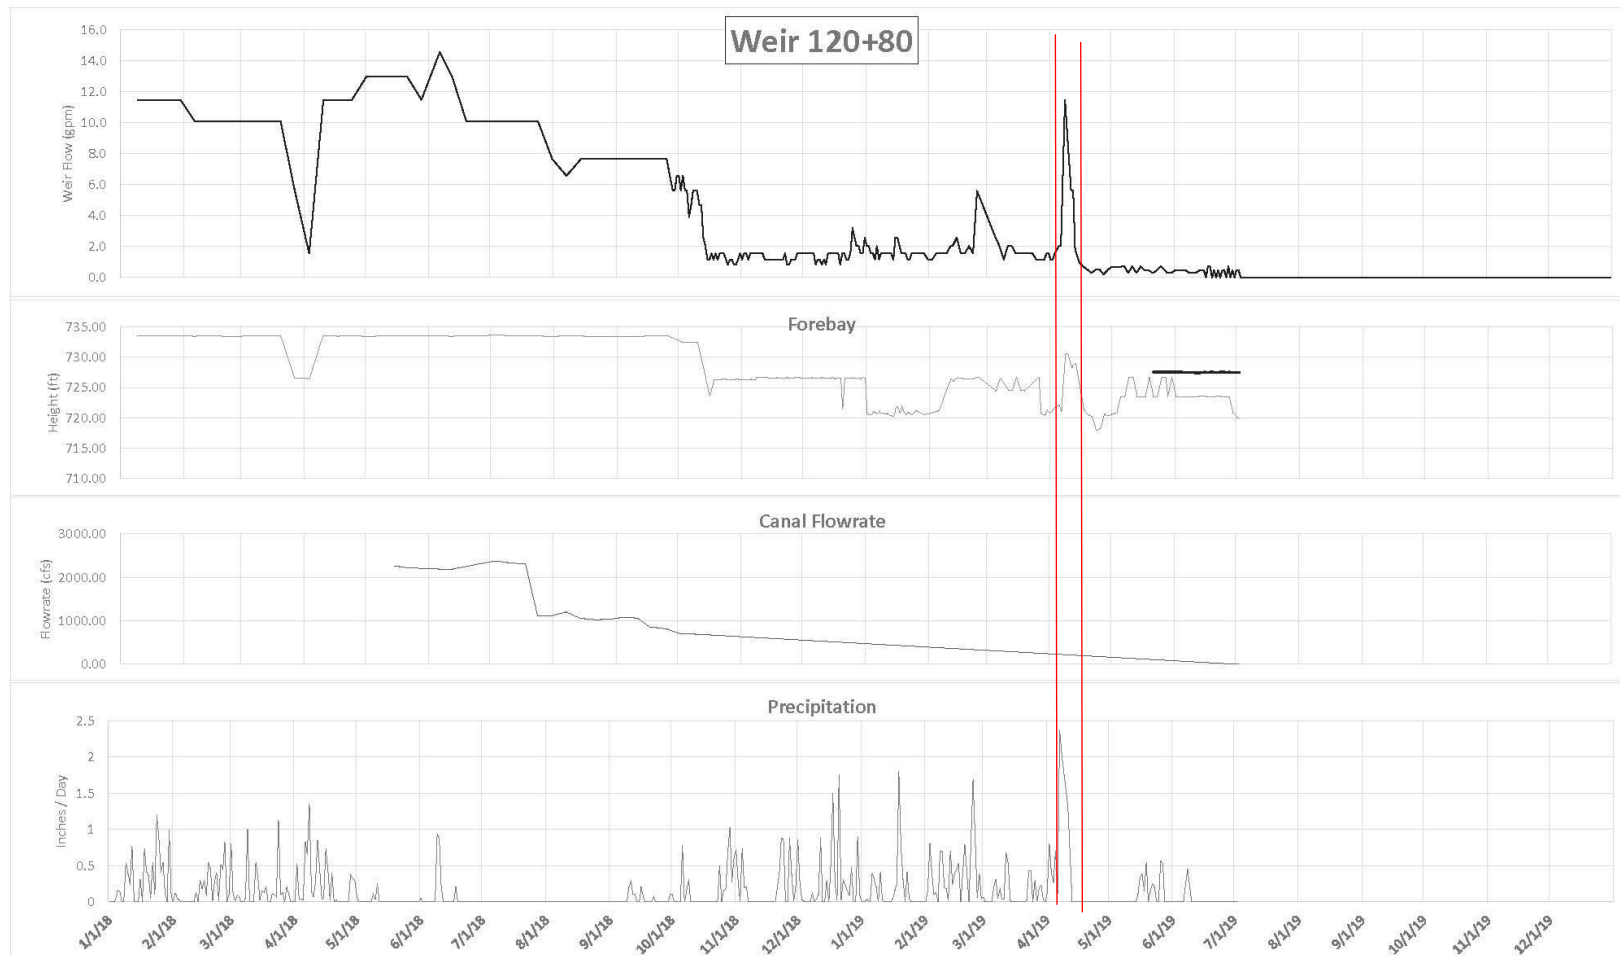
Between April 8 and 14, 2019, a significant precipitation event resulted in a canal water surface elevation of 730.5 feet, with the targeted drawdown elevation exceeded for six days (Enclosure, Figure 1). The following table, from Mr. Olmstead's April 17, 2019 email to Ms. Kristie Hartfeil, of this office, provides precipitation and forebay data during this event.

Daily weir instrumentation readings since October 1, 2018 indicate continuing seepage flow and sediment accumulation in the weir at Station 120+80, even at the drawdown elevation. This is a strong indicator that internal erosion of the canal embankment continues to occur and the current drawdown is insufficient. During the April 2019 precipitation event, EWEB staff observed a 24-foot-wide by 10-foot-high slough on of the interior side of the canal embankment at Station 125+00. While the canal water surface was above the drawdown target elevation, weir flows at Station 120+80 spiked to pre-drawdown flows.

Figure 1. Seepage Flow at Weir 120+80. Note heavy precipitation event April 2019.

2. Decrease the water surface level in the Leaburg Canal. EWEB is required to make every additional effort to reduce the canal water surface to an elevation where sediment is no longer being transported at Station 243+00, or to a low enough elevation that a breach of the canal would not pose a threat to downstream lives and property.
3. Provide additional discharge capacity. During a heavy precipitation event, EWEB will be unable to maintain the required drawn down elevation with the existing gate structures. EWEB is directed to find alternative means for discharging excess flows from Leaburg Canal to maintain the required drawdown water surface elevation.

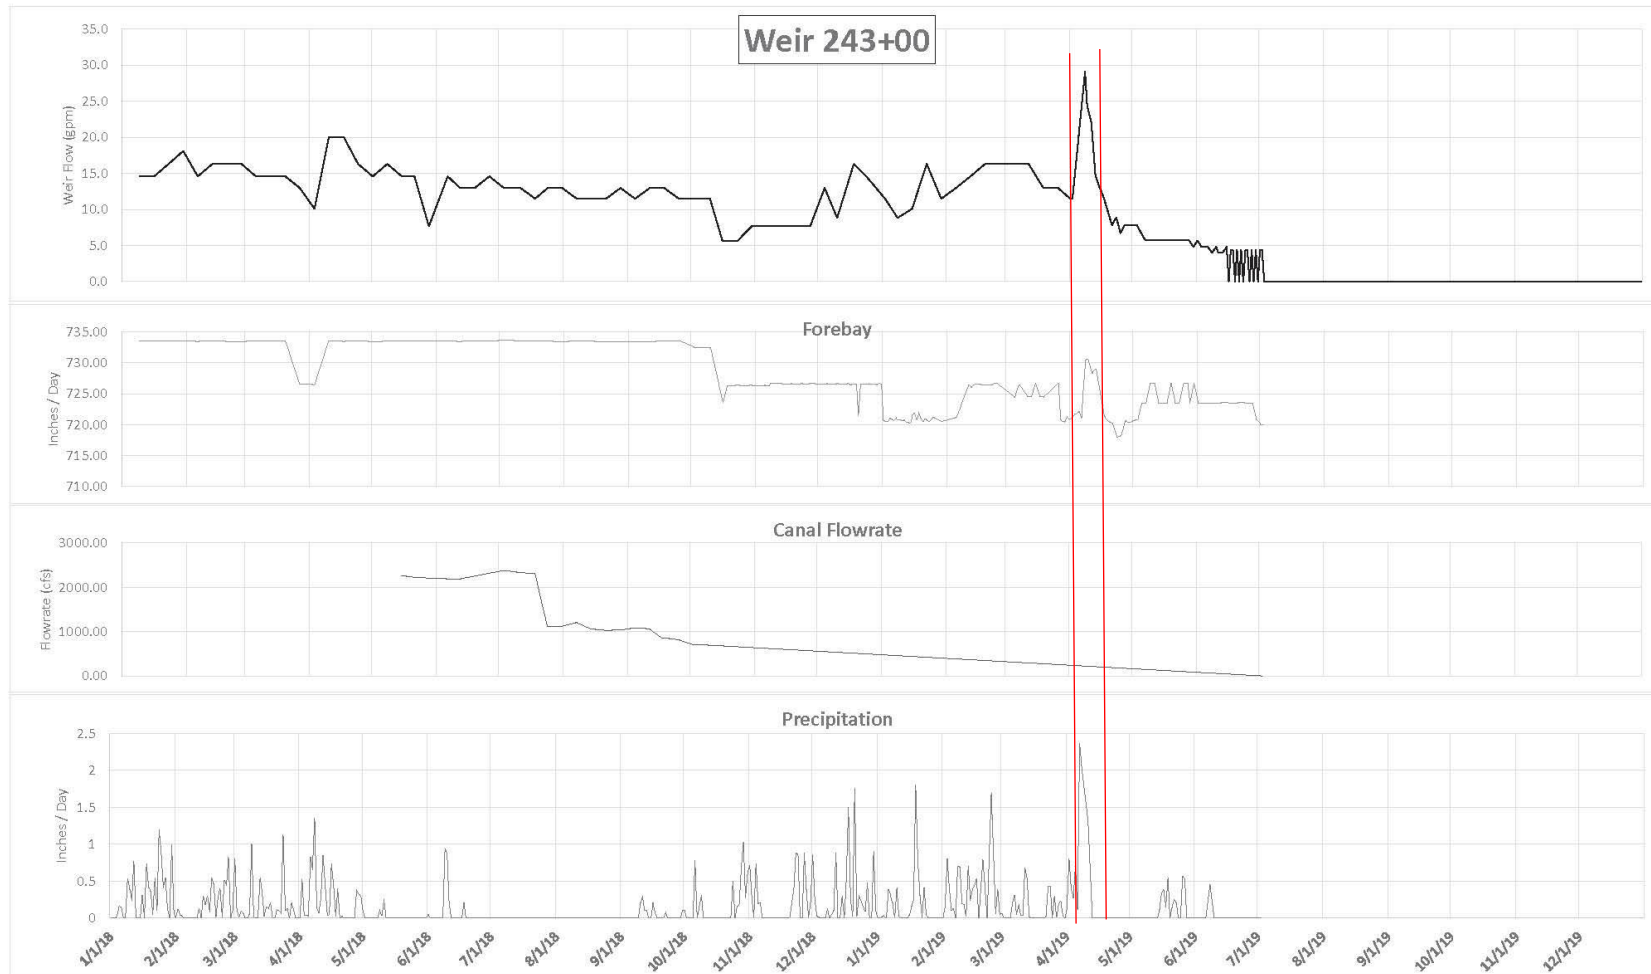
and tension cracks on the downstream face of the canal embankment near Station 237+00. The weir box at Station 243+00 is one of the oldest along the 90-year-old canal and has a history of significant seepage flows and sediment accumulation. Prior to the canal drawdown, seepage flow rates from the weir at Station 243+00 had been increasing over time. D2SI-PRO staff have observed the weir box floor covered with sediment on numerous occasions, including the April 3, 2019 inspection. During the April 2019 precipitation event, the weir recorded its second highest flow in the past fourteen years. The threshold level for the weir at Station 243+00 is 22 gpm; the maximum recorded weir flow reached nearly 30 gpm during the event (Enclosure, Figure 2). All of these factors appear to indicate that internal erosion of the canal embankment is occurring at Station 243+00.

Figure 2. Seepage Flow at Weir 243+00. Note heavy precipitation event April 2019.
